# SERVICE BULLETIN

## Removing Frozen Hubs From The Spindle

All ConMet® hub assemblies

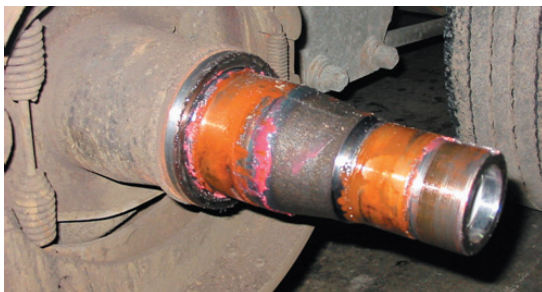
1. Minor wheel bearing failure
2. Fretting corrosion between the bearing cones and axle spindle (see Figure 1 and Figure 2)

**Fretting Corrosion is corrosion that can occur on the load bearing contact surface between mating material, leaving a reddish-brown stain on the spindle or bearing cone.**

Depending on the degree of the wheel bearing failure, or fretting corrosion, a considerable amount of force may be required to remove the hub assembly from the spindle. Consolidated Metco recommends the use of a heavy duty mechanical hub puller (see Figure 3) to assist in the removal of the hub from the spindle. Although ConMet is not a manufacturer or supplier of these tools, hub pullers are available from several sources including:

During the disassembly of the hub, all hub components should be cleaned, dried, and inspected for fatigue or failure. If signs of deterioration are evident, it is required to replace these components as per the hub or bearing manufacturer’s recommended practices. In cases where fretting corrosion is found on the spindle bearing journals, it should be removed with a fine abrasive, such as emery cloth, prior to reinstalling the hub assembly. Consolidated Metco recommends that a thin coating of a grade 2 grease, preferably moly based be applied to the spindle bearing journals prior to installing the hub to prevent fretting corrosion from reoccurring.
